INTERIOR

1801 Ashton Road, Ashton-Sandy Spring, MD July 14, 2022

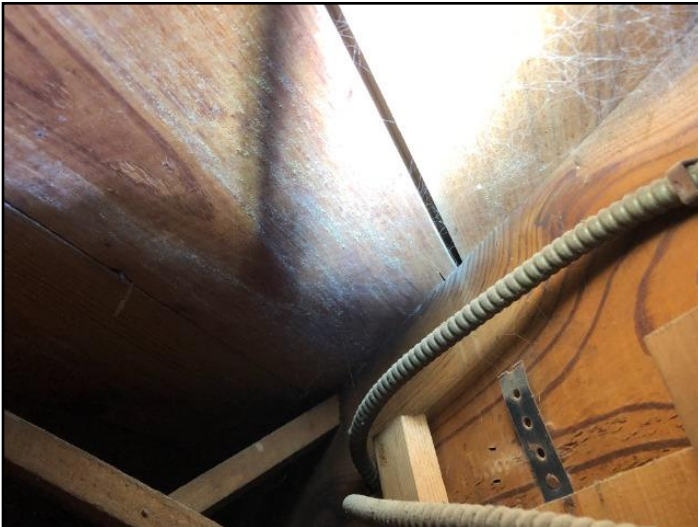
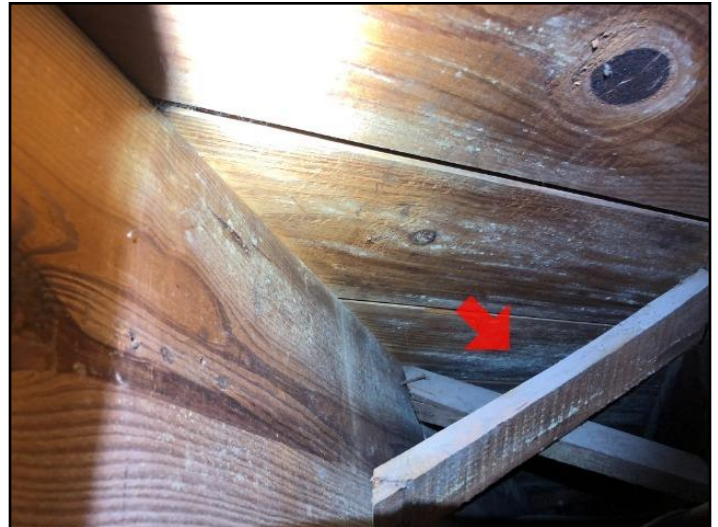
Sample

66. Condition: • Probable Mold/Sampled: Evidence of what appears to be mold was observed in the noted area(s). Conditions conducive to mold usually arise as the result of elevated moisture levels. Destructive actions for identifying additional evidence are beyond the scope of this inspection. Sampling and analysis should be undertaken to confirm the presence or absence of mold. If mold presence is confirmed, remediation is recommended. The ANSI S520 standard for mold remediation does not advocate any chemical (spray, fogging, etc.) or encapsulation (paint, sealant, etc.) treatment to remedy a mold condition. Materials testing positive for mold are removed or cleaned based on their composition. While other mold remediation methods are advertised or available, we cannot confirm their effectiveness in removing or controlling mold. Be aware that remediation should be accompanied by an action plan to address any chronic moisture source, and should be followed up with third-party testing for mold presence. Mold sampling was requested by the buyer and undertaken at the time of the inspection.

Location: Basement

Task: Further Evaluation
